> HNF-EP-0182 Revision 343

Waste Tank Summary Report for Month Ending July 31, 2016

Prepared for the U.S. Department of Energy Assistant Secretary for Environmental Management

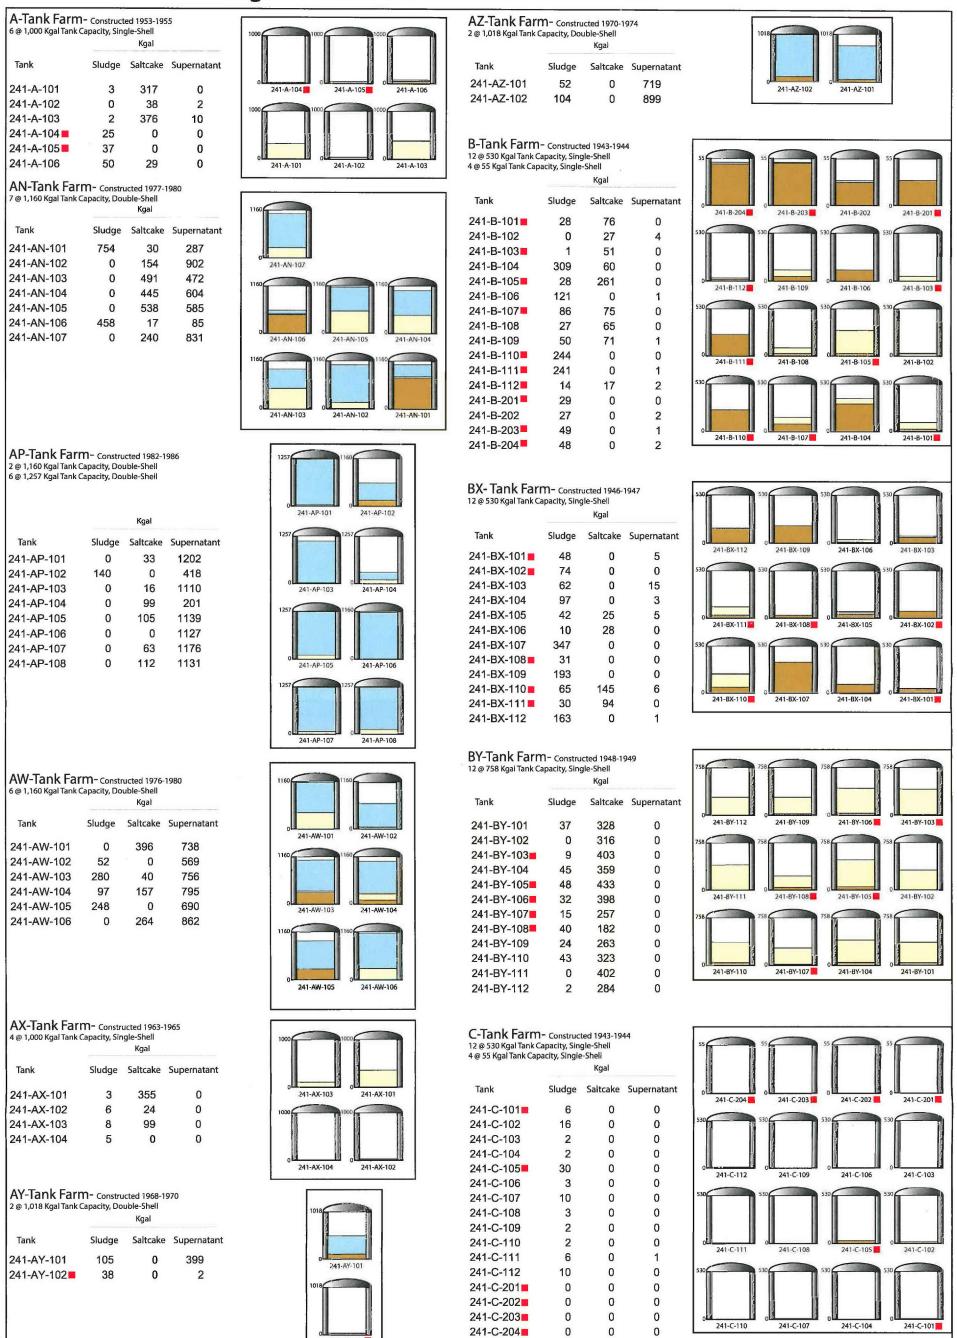
Figure 1-3. 200-East Tank Waste Contents

Sludge Saltcake Supernatant Available Space Assumed/Confirmed Leaker
